An Experimental Study of Beaver and Beaver Dam Analogue Restoration Techniques in Childs Meadow

Center for Watershed Sciences, UC Davis The Nature Conservancy USFS Pacific Southwest Research Station Point Blue Conservancy

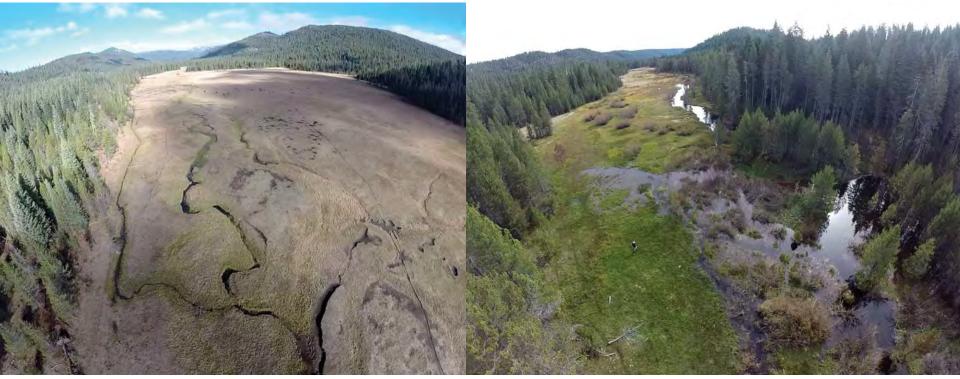
Pre-treatment Reaches

- 100+ years of grazing
- Removal of timber from 1941-1974
- Ditching on edges of meadow by 1974
- Channel incised on average 1.6 ft, lacks woody vegetation
- Historic removal of beaver?

Images flown same day, Oct. 2014

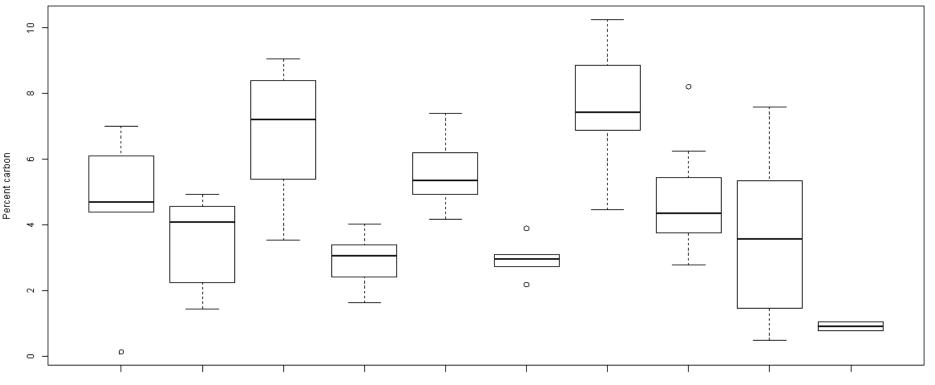
Carbon Sequestration – Effect of fencing

0-10cm 10-20cm 0-10cm 10-20cm 0-10cm^{te} 10-20cm 0-10cm 10-20cm Beaver Stream Neg Cntrl Neg Cntrl Fence Fence BDA BDA Beaver Beaver Ponds Channel Only Only

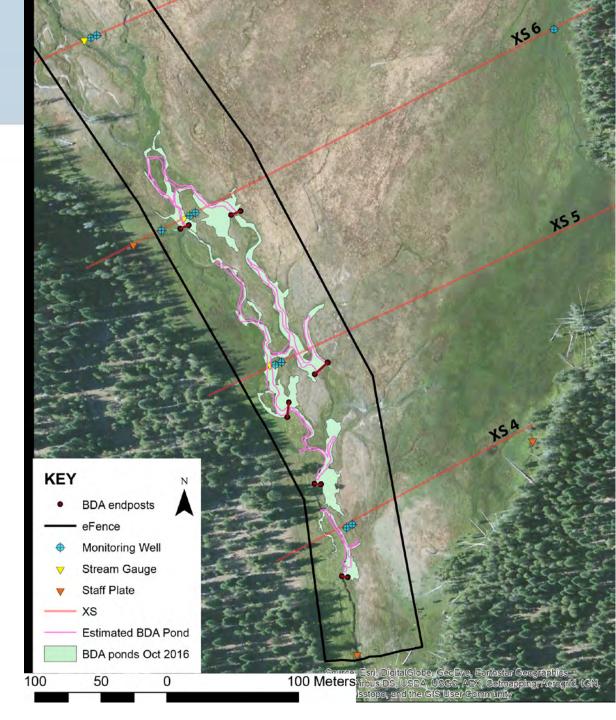
BDA Inundation

- Full inundation in less than 24 hours
- Mapped surface water extent from aerial drone flight approximately 2 weeks after install
 roughly 3-4x predicted extent

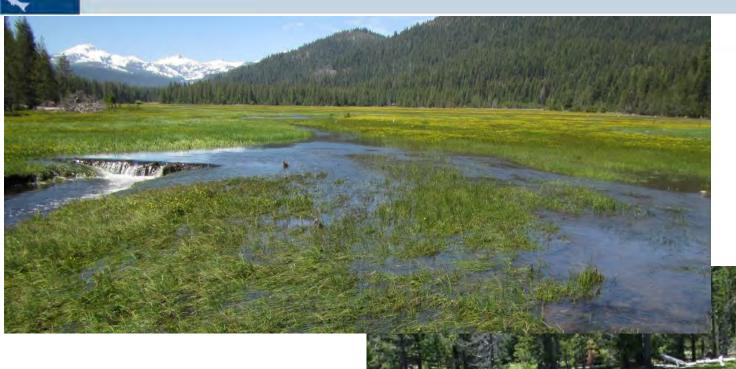
May 2017 – Wet Spring Conditions

BDAs withstood high winter flows

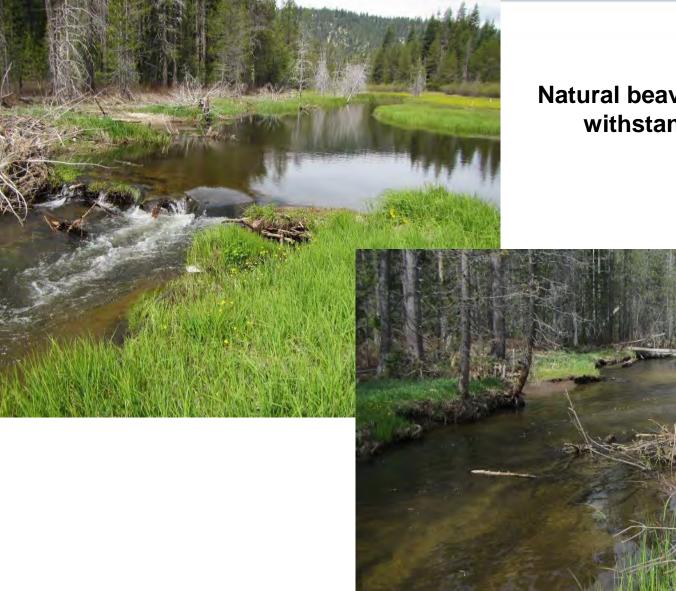
May 2017 – Wet Spring Conditions

Natural beaver dams did not withstand high flows

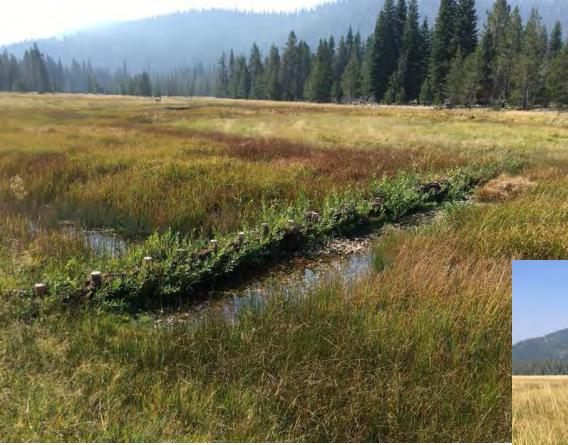
Aug 31 2017 – Summer Conditions

Leaky dams - BDA maintenance required

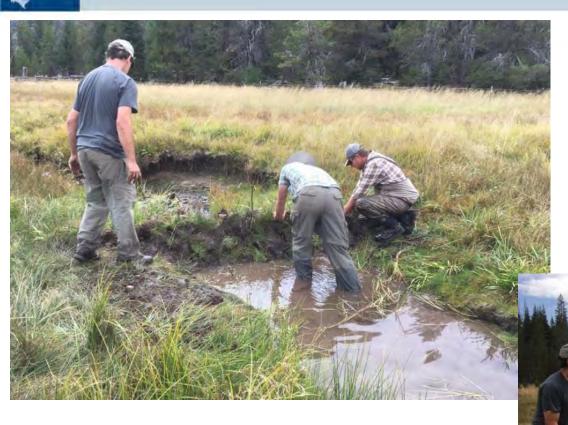
September 2017 – Summer Conditions

BDA maintenance - repacked dams from meadow materials
